Defect Detection & Prevention In Cast Turbine Wheels

A novel approach for improving
turbine wheel quality using eddy current
inspection

Jack Rose

September 2015

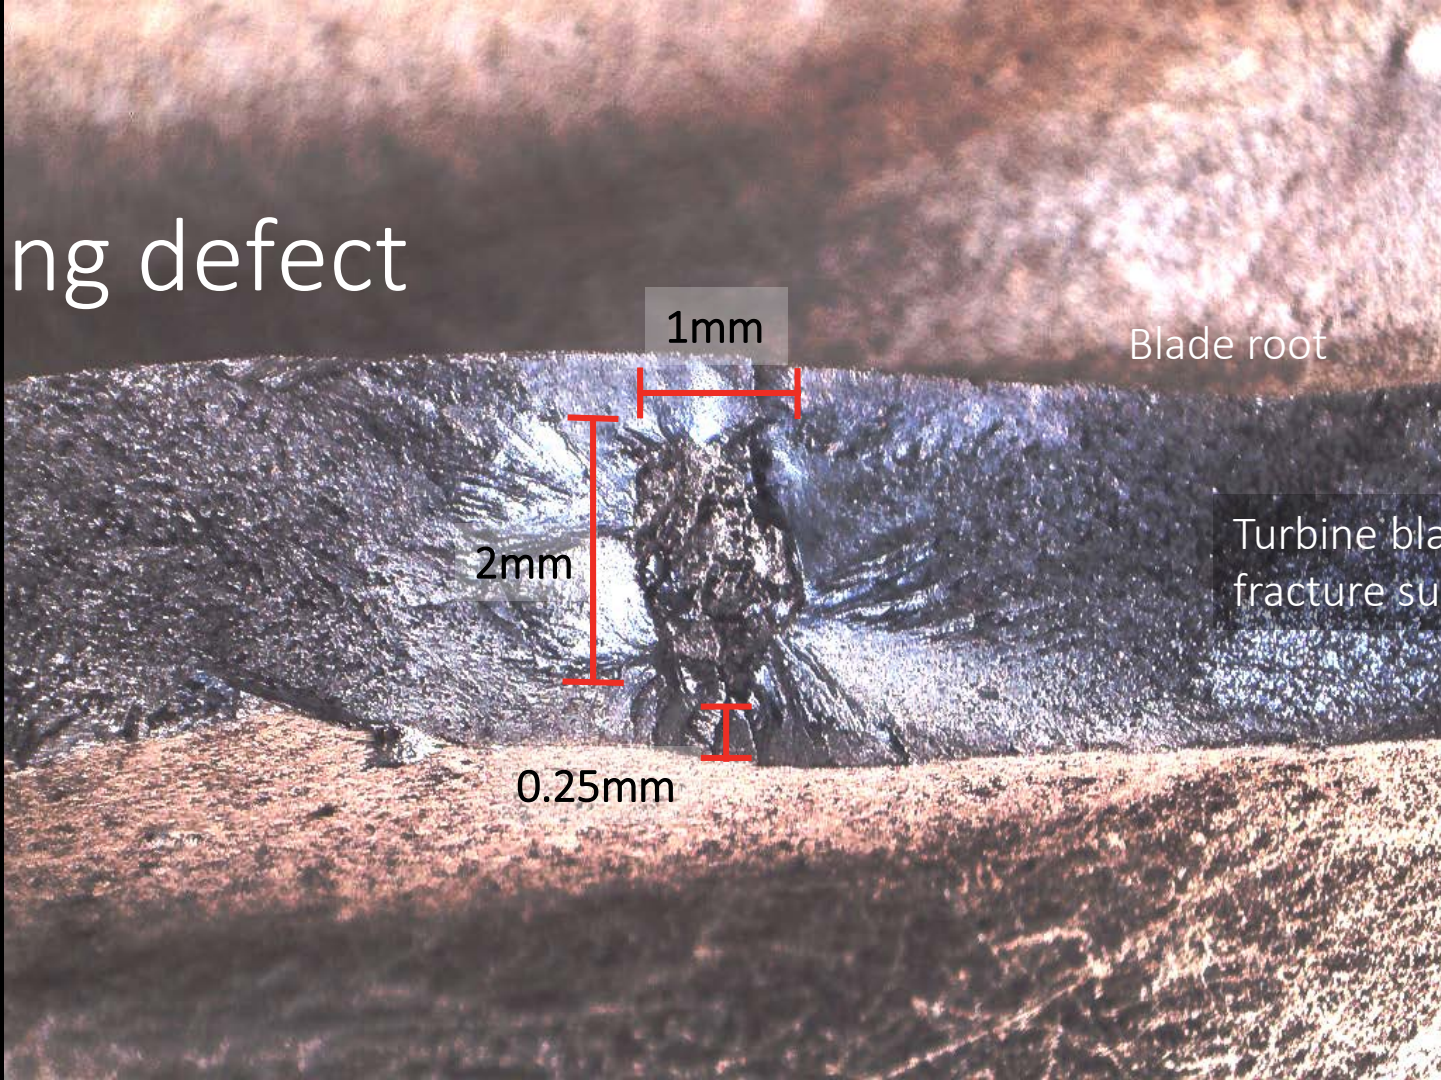
Casting defect

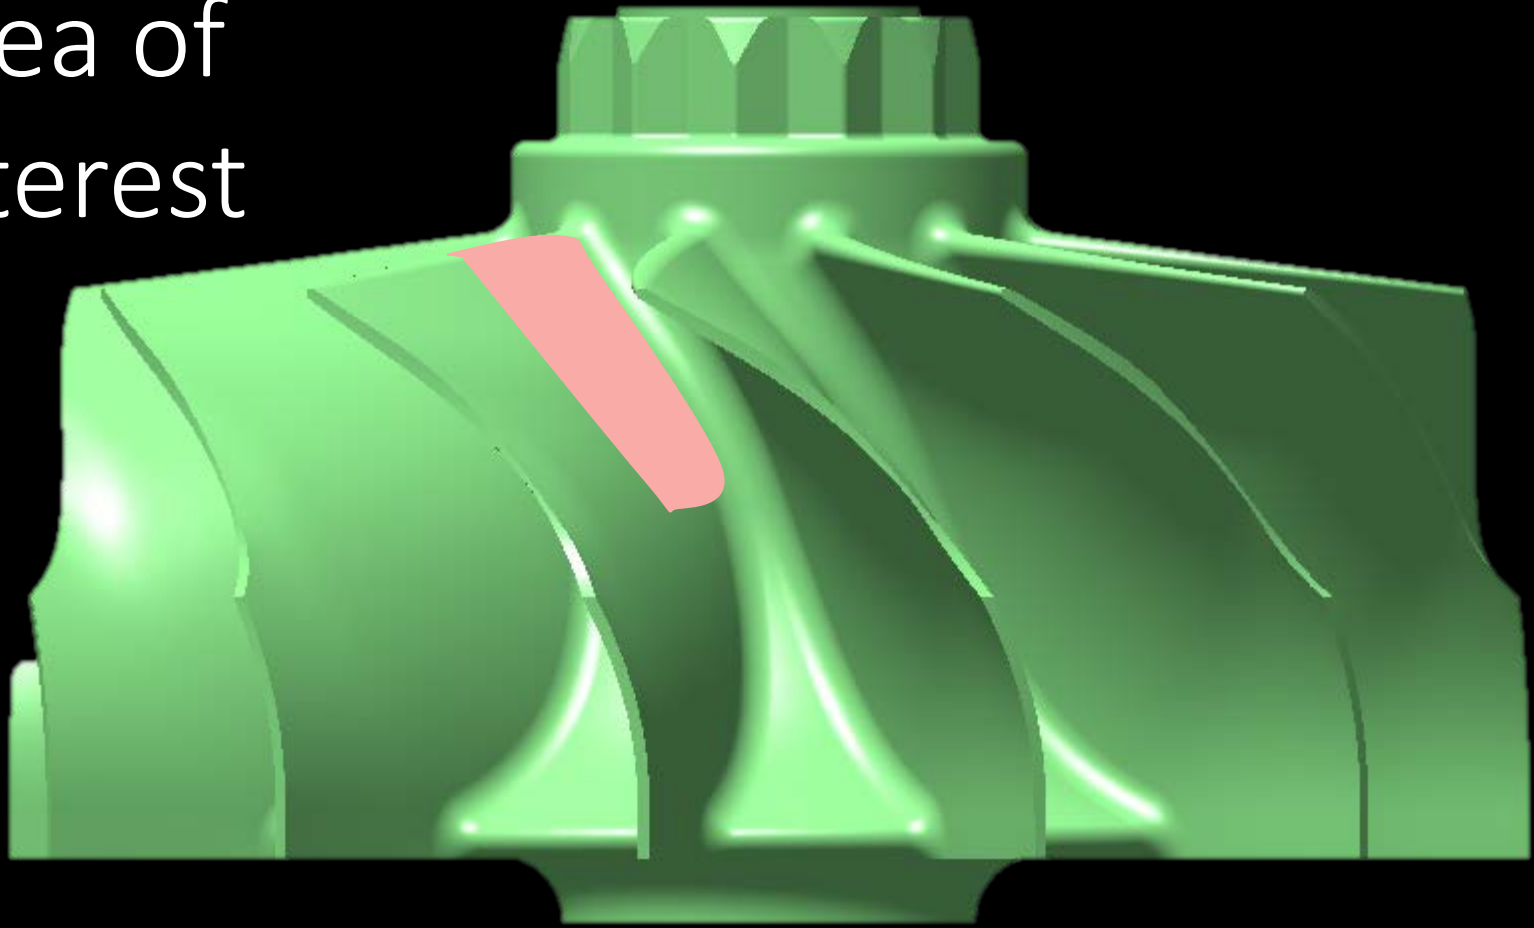
Blade root

Turbine blade fracture surface

Area of
Interest

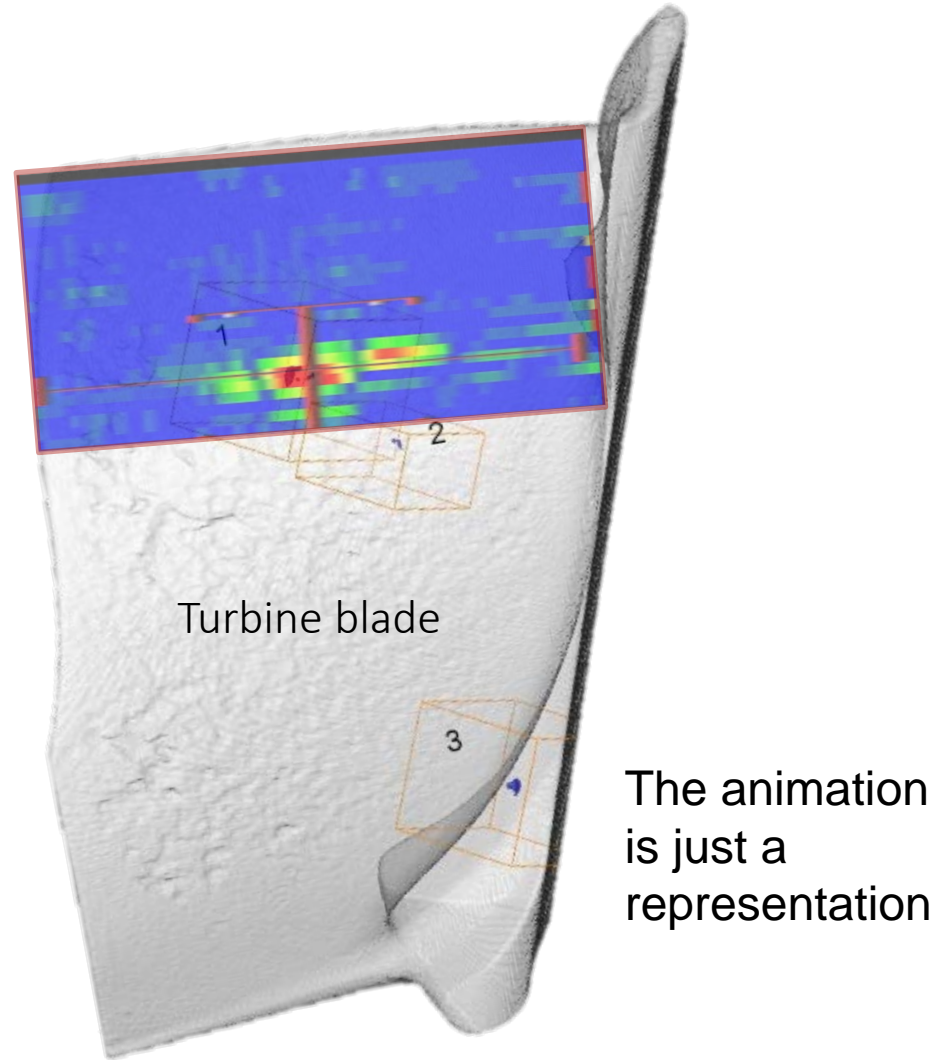
Real defect on real component

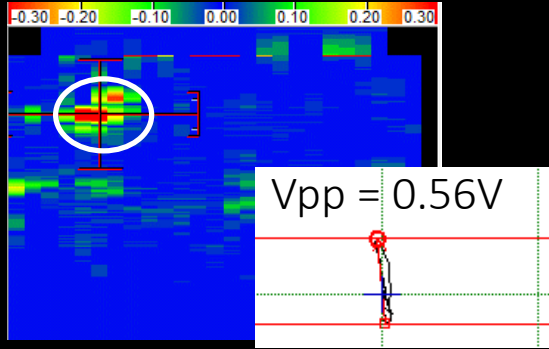
Real defect on real component

500 kHz scan

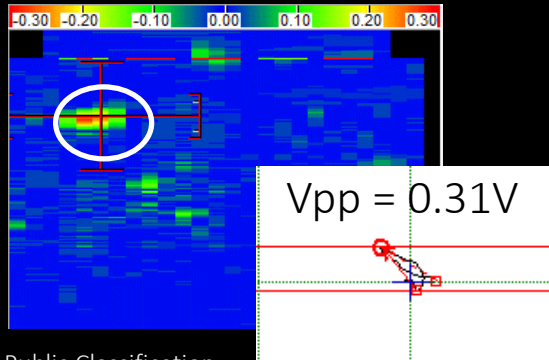
300 kHz scan

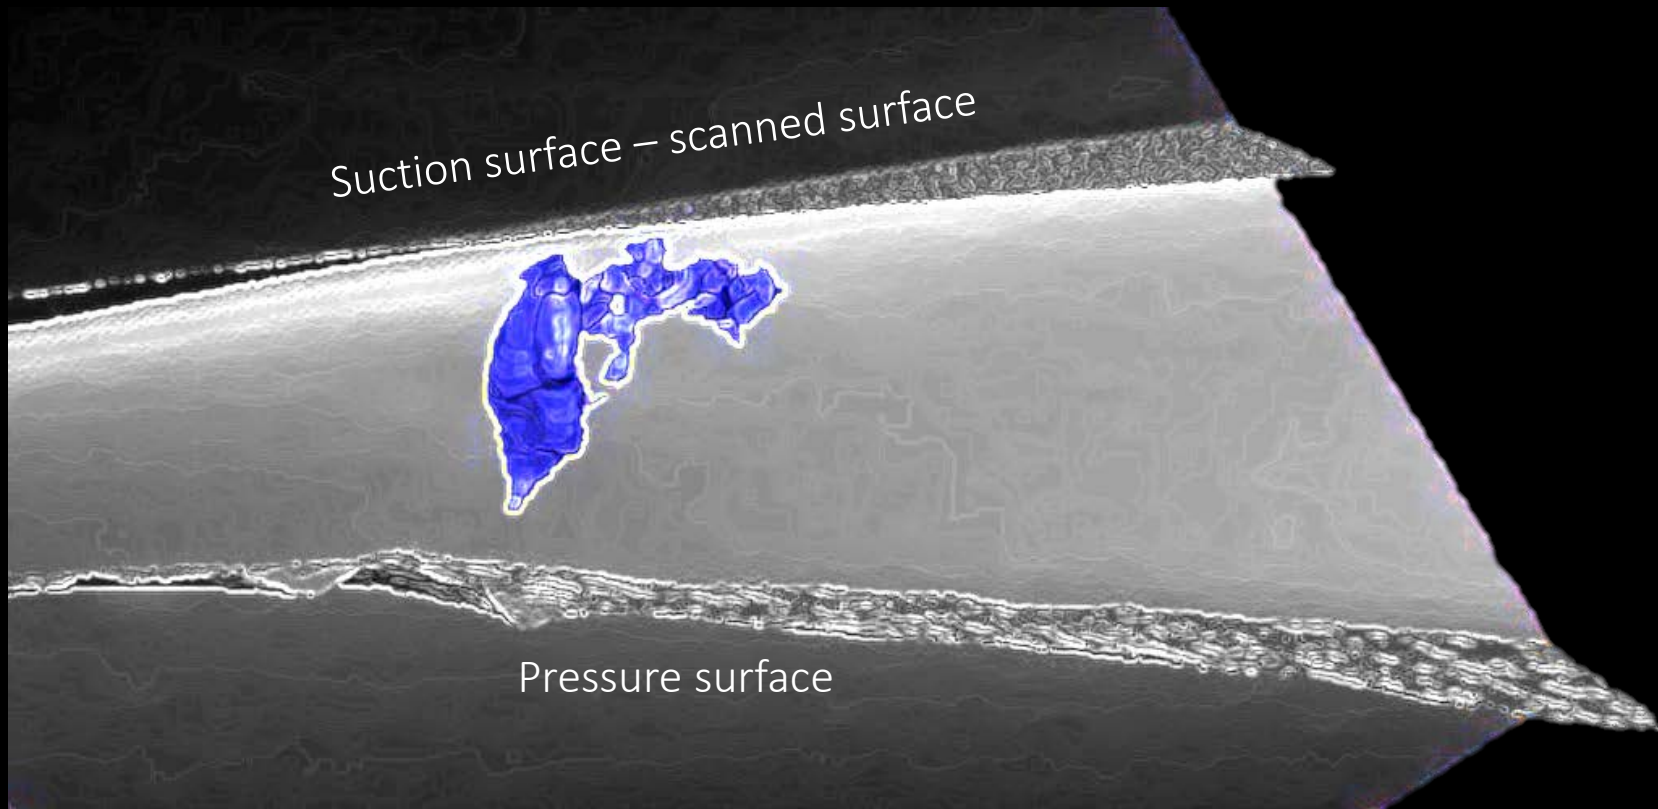
Defect detected by 3DXRCT and analysed at the University of Manchester (MXIF) highlighted artificially in blue

1. **Identify** process that introduces defects into casting
2. **Consider** methods for reducing effect of this process
3. **Monitor** defect count on casting optimisation trials
4. Perform durability tests to **validate** improvements by eddy current inspection
