ASSESSING BURIED AVIATION FUEL TANKS FOR FITNESS FOR PURPOSE

Determine condition of large, semi-buried aviation fuel storage tank located in southern England

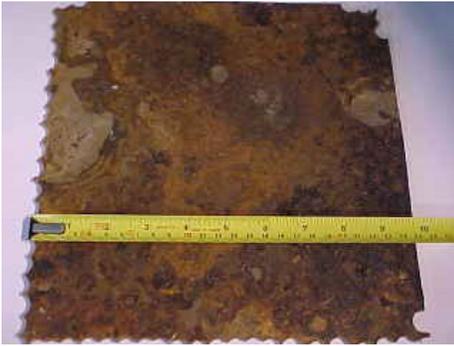
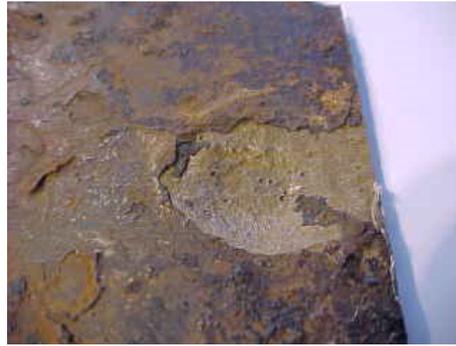
With access provided to the cleaned tank, inspection was performed utilizing advanced Silverwing instruments. Visually, the floor plates appeared to be in excellent condition considering the age of the tank. However, a Magnetic Flux Leakage (MFL) survey identified multiple areas of tank floor that had been attacked by underfloor corrosion. The most severe corrosion was recorded at 75 percent loss of the nominal plate thickness. Several coupons were selected to be cut from the floor, and physical measurements verified the accuracy of the MFL results. Despite the severity of corrosion, results showed that most of the corroded regions were limited to isolated or localized areas, so the tank was deemed repairable.

Left to right: Underside of floor cutouts showing underfloor corrosion; characteristic circular staining around weld highlights pinhole type leak

to take more cost-effective measures than replacement offered. All corrosion more than 60% loss was repaired, and a five-year internal inspection regime was introduced for all tanks onsite.

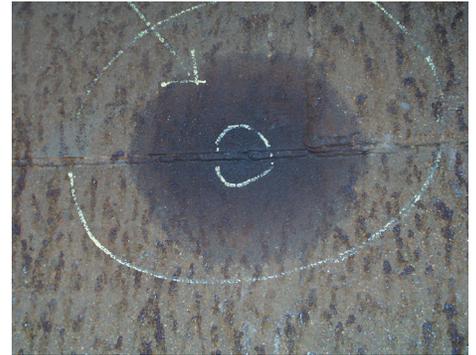
no significant thinning detected. A leak was noted on a shell plate weld during this inspection. Although the perforation in the weld was extremely small, it was easily identified by a characteristic circular damp area caused by leaked product being drawn back into the tank due to capillary action. This was remedied using a "chemical metal" compound.
