TELETEST™ FOCUS+ IN DESERT ROAD CROSSING INSPECTION APPLICATIONS

Eddyfi Technologies inspected a below-grade pipeline at road crossings in the Sahara desert, North Africa with the Teletest™ FOCUS+ guided wave system.

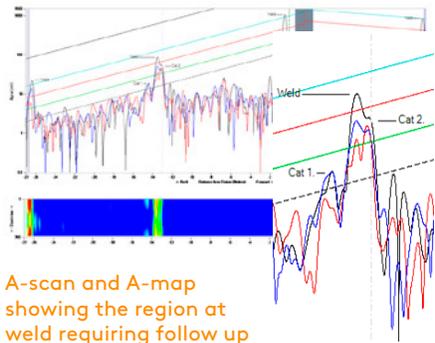
A particular region highlighted in the scan above was identified for follow-up. It is clear from the A-scan that the girth weld signal is very irregular when compared to the other three remaining welds. A category 2 and a category 1 indications were also noted adjacent to the suspect weld.

A-scan and A-map showing the region at weld requiring follow up

The customer excavated this region to find extensive external corrosion around the weld and in the region adjacent to it. After performing manual UT, the remaining wall thickness was found to be 5.8 mm (0.23 in) from the nominal 9.6 mm (0.38 in). The road crossing was subsequently decommissioned and production flow rerouted through an alternative crossing.

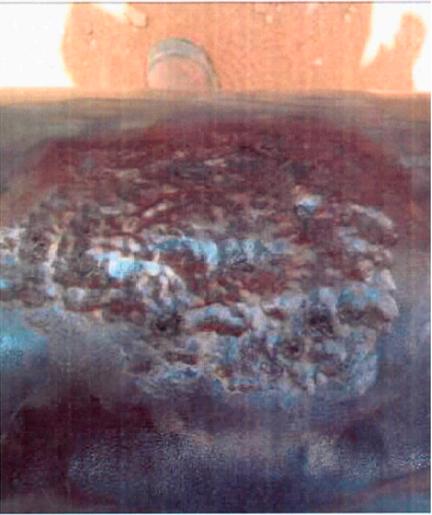
A close up of one area of corrosion identified adjacent to weld
