ASSESSING FLOW-ACCELERATED CORROSION IN HARD-TO-REACH PLACES

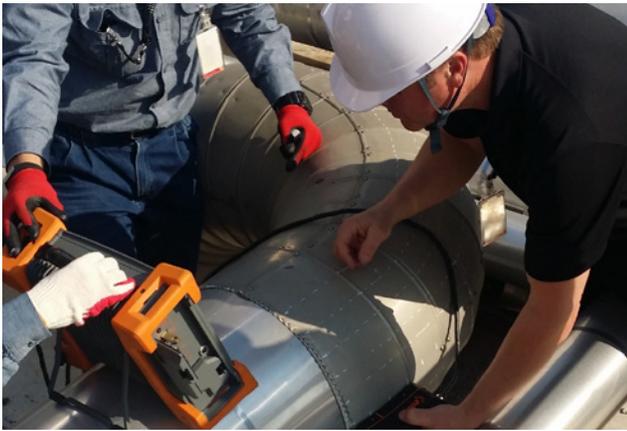
The second target area was the outermost curved surface (extrados) of an elbow, upstream from the first area. It was possible to hear the fluid as it accelerated around the bend in the elbow. The structure of the aluminum weather jacket elbow precluded the possibility of using the dynamic scan mode (the irregular surface and sudden step changes

Grid scan of elbow extrados

did not allow the encoder to operate properly). A 50x50 mm (2x2 in) grid was mapped out on the surface of the elbow so that the scan area was the elbow's extrados (where FAC was most likely to occur).

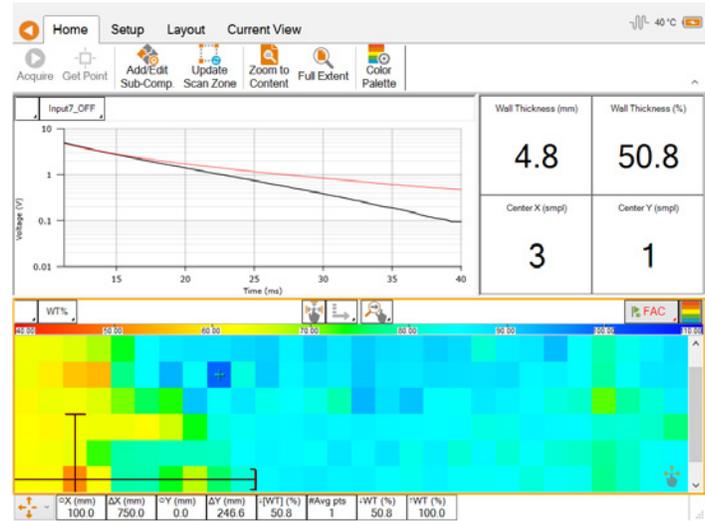
Elbow grid scan results

Inspection results indicated substantial wall loss concentrated at the bend transition and continuing through the extrados of the elbow, the extent of which was not anticipated.
