ASSESSING FLOW-ACCELERATED CORROSION IN HARD-TO-REACH PLACES

THE CHALLENGE

A major petrochemical refining company in Asia challenged Eddyfi Technologies to come up with an inspection solution capable of detecting FAC and erosion in carbon steel pipes and elbows containing high-temperature fluids travelling at high velocity.

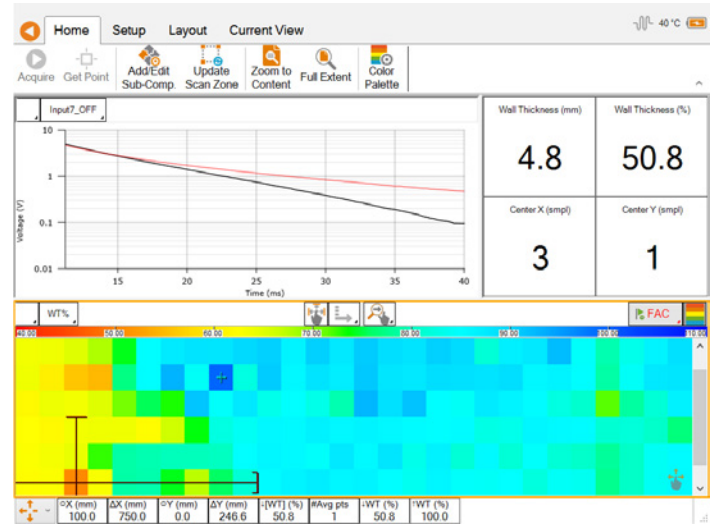
Elbow grid scan results

Inspection results indicated substantial wall loss concentrated at the bend transition and continuing through the extrados of the elbow, the extent of which was not anticipated.
