A Novel Approach for Improving Turbine Wheel Quality Using Eddy Current Inspection

Jack Rose, Sean Winwood

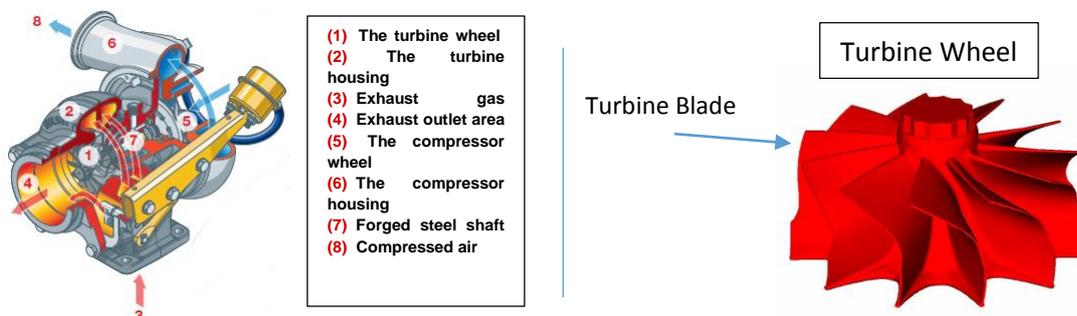
Figure 1: Left: Schematic annotated diagram of a waste-gated turbocharger (2). Right: turbine wheel schematic diagram

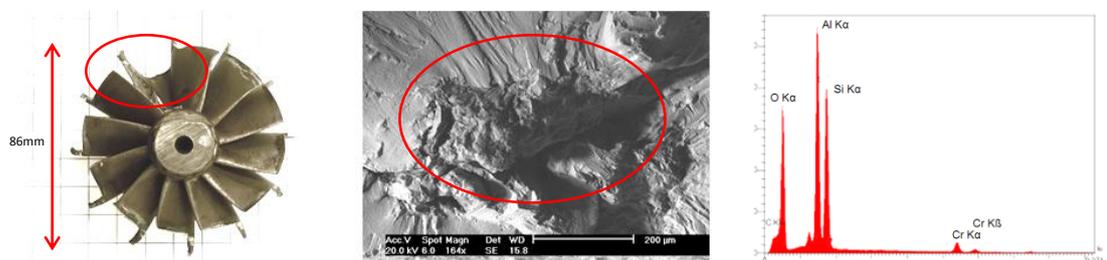
Figure 2: Example LCF failure of turbine wheel. Left: Front face of the turbine wheel showing damaged exducer. Centre: Secondary Electron SEM image of sub surface (by 100µm) inclusion measuring 300µm * 200µm in size. Right: Energy Dispersive X-ray Spectroscopy showing semi-quantitative elemental readings, showing high Al, Si and O peaks consistent with a casting shell inclusion.

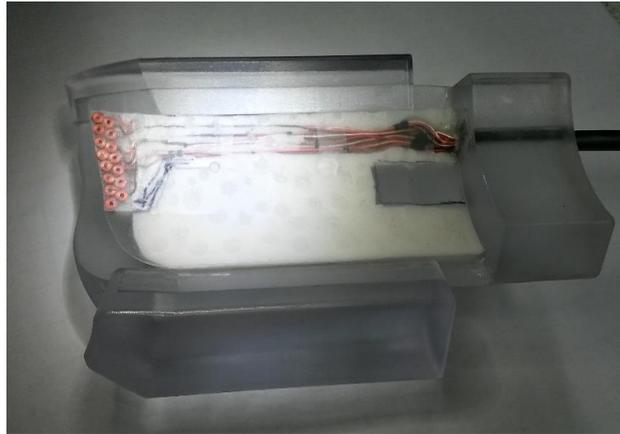
Figure 4: Photograph of bespoke flexible probe in probe holder

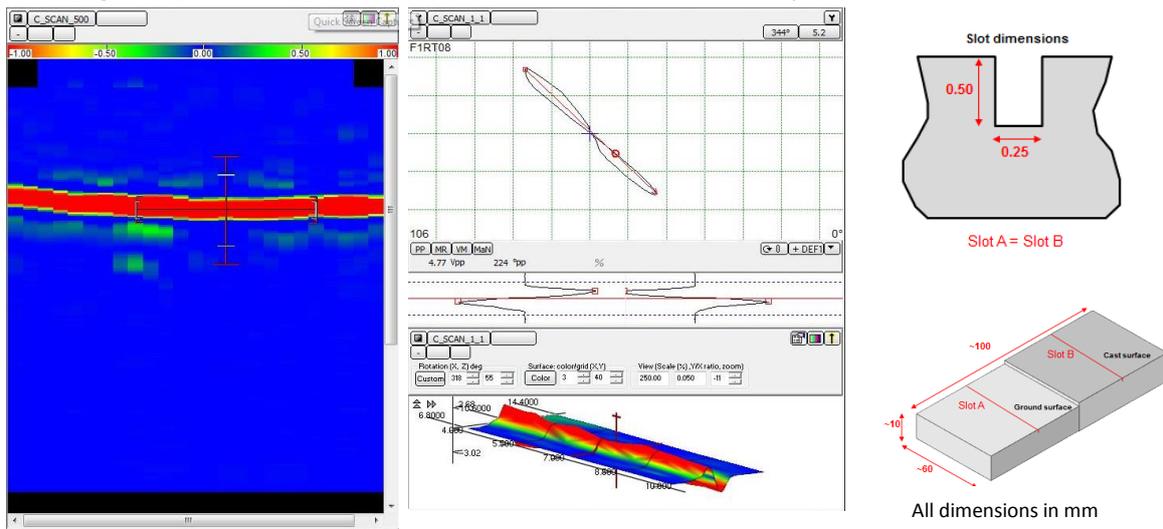
Figure 5: Calibration slot scan of EDM slot on the machined surface

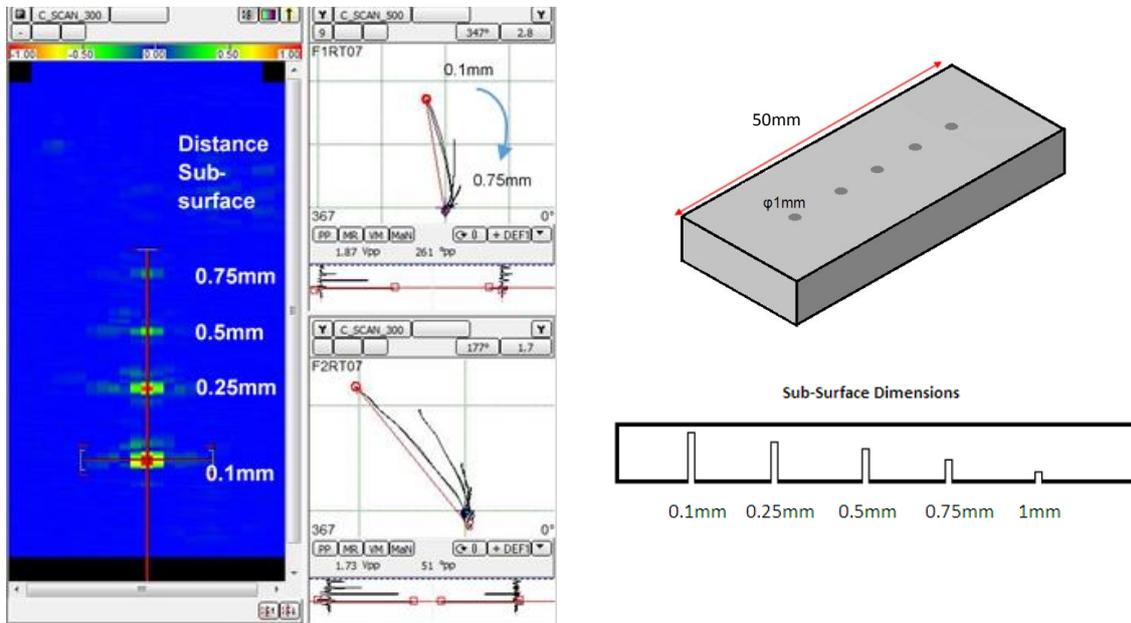
Figure 6: Reverse of calibration block with varying depths of sub-surface EDM slots.

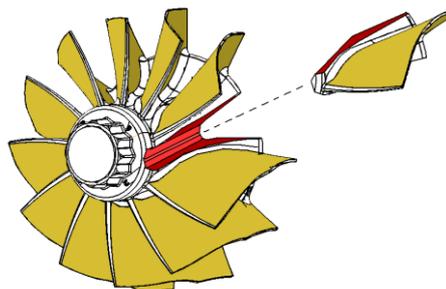
Figure 7: EDM was employed to carefully remove the blade

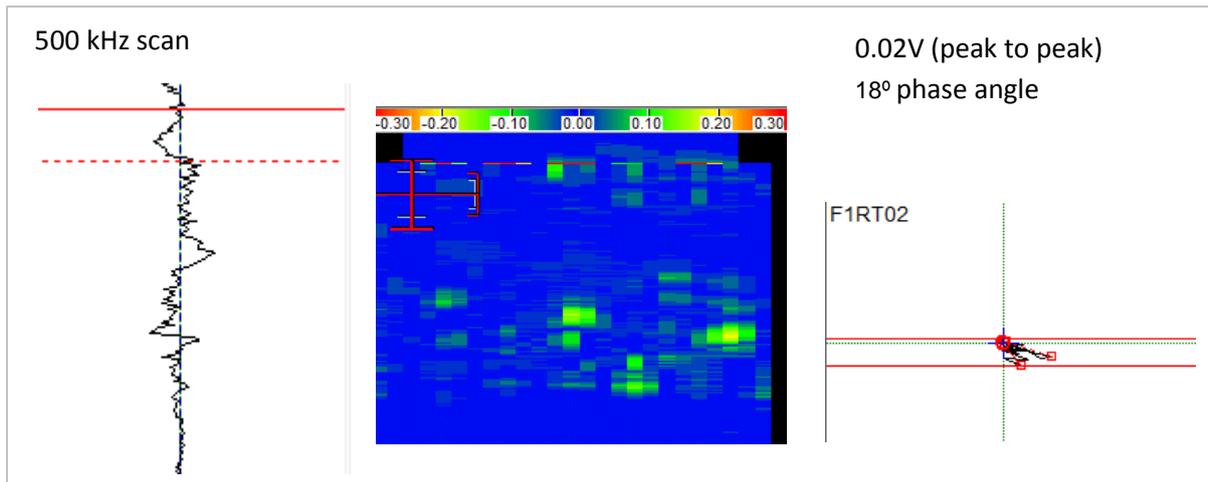
Figure 8: typical wheel scan with no known defects. Left: A-scan, Middle: C-Scan; Right: voltage plane diagram

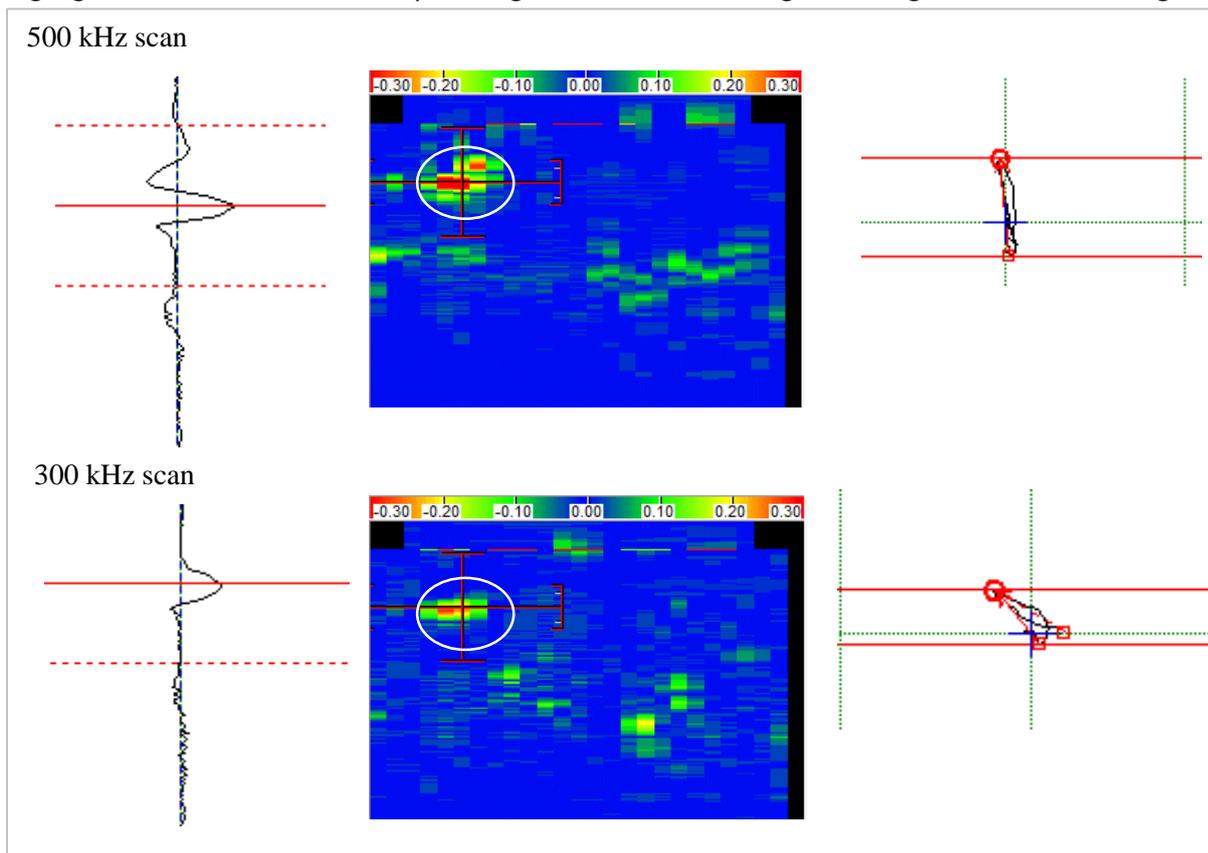
Figure 9: Typical turbine blade scan with potential defect indication

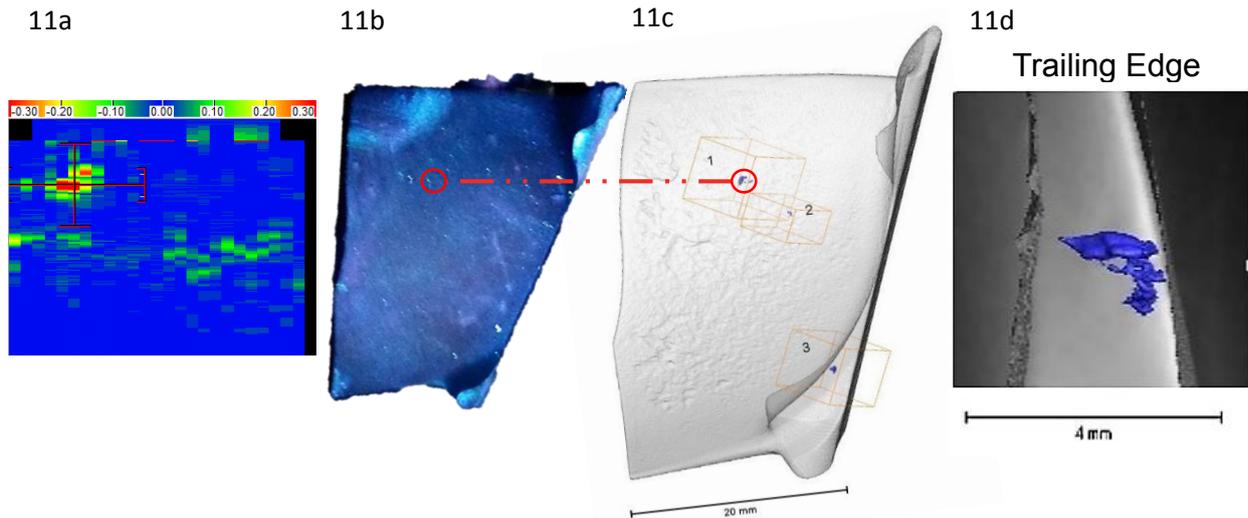
Figure 10: Correlation between Eddy Current, FPI and 3DXRCT. 11a: eddy current scan of blade. 11b: image of blade following FPI procedure with no visible bleed out. 11c: volume rendered XRCT image with defect highlighted blue. 11d: cross section of an approximately 100µm subsurface defect found through 3DXRCT.
