EFFECTIVE THERMAL FATIGUE CRACKING CHARACTERIZATION IN PIPELINE BRANCH CONNECTIONS

Ensuring the smooth operation of pipelines responsible for transporting contents throughout different areas of a process plant depends on regular assessment of the pipework including all branch connections. Because pipelines and other factory components are exposed to cyclic thermal stresses like those incurred from extreme temperatures or condensate and steam system contact, they are more susceptible to fatigue cracking. To maximize productivity in an economy that demands efficiency, Non-Intrusive Inspection (NII) is necessary to determine Fitness-For-Service (FFS) of these online assets.

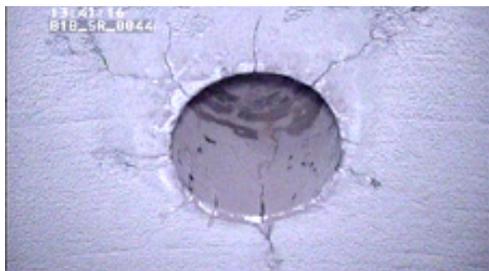
Figure 1: Thermal Fatigue Cracking

Thermal fatigue cracking, or TFAT, damage is a real threat to branch connections, and conventional A-scan ultrasonic techniques are the current NII method for detecting this defect.

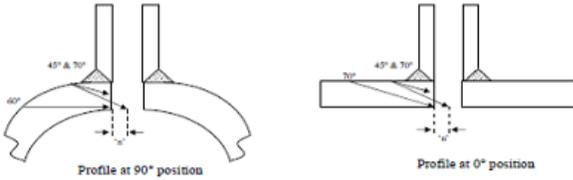
Figure 3: Inspection coverage of a typical branch connection

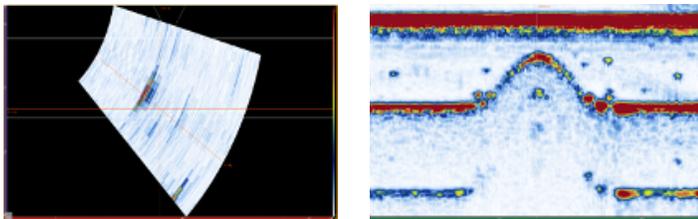
Figure 4: Sectorial angular sweep (left), fixed angle linear scan set to zero degrees (right)

The resulting bulk wave can take two forms: sectorial or linear. In a linear scan, all focal laws employ a fixed angle beam, whereas sectorial scans use fixed apertures and steer through a sequence of angles.

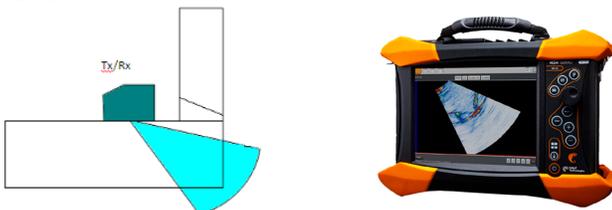
Figure 5: Sectorial scan from 90/270 position with phased array response

First, the crotch corner from each cardinal position was individually located, the greatest response being from the 90 and 270 position. The focal laws selected were governed by the part geometry to ensure the entire pipe bore was evaluated. Next the probe was rotated to the branch tangent. If no reflector was present (EDM notch), there was no response within the Sectorial scan, or S-scan. Manipulating the probe maximized the phased array response when a recordable response was detected.

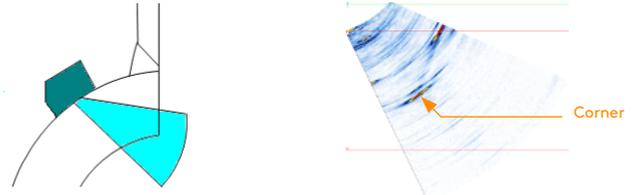
Figure 6: Sectorial scan from 0/180 position with phased array response

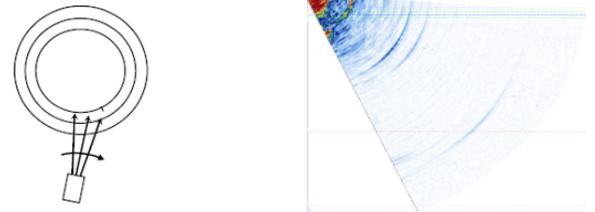
Figure 7: Tangential scanning showing phased array response with no reflectors present

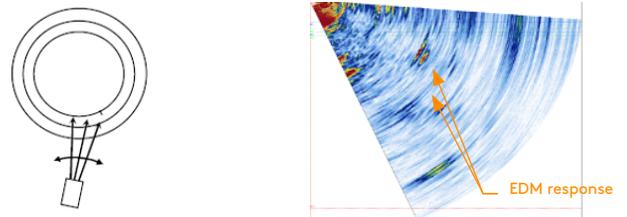
Figure 8: Optimized tangential scanning showing maximized phased array response from an EDM notch reflector

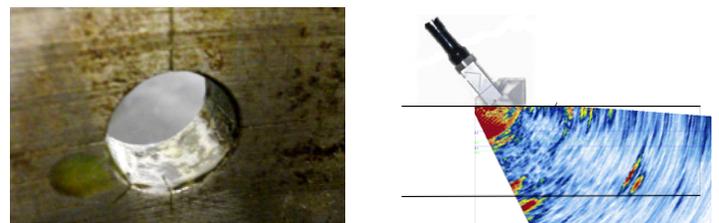
Figure 9: EDM slots in ID bore (left), phased array response showing corner response and tip diffraction from EDM slot

The operator then sized detections with recognized signals caused from the top and bottom of the defect. The damage typically breaks the pipe inner diameter (ID) surface and therefore creates a corner type response which can be easily recognized. The operator interpreted diffraction signals generated from the tip of the flaw which allowed measurements between the two signals. Length sizing requires operators to keep the probe perpendicular to the defect/reflector and assess the length by using dB drop method; it should be noted that due to the complexity of the joint construction, the radial extent is given with +/- 5 millimeter (0.2 inch) margin of error.

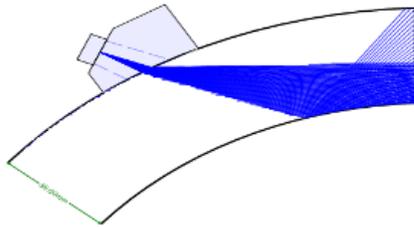
Figure 11: Sectorial scan at 0/180 position on 35mm sample—angles from 40° to 65° showing full coverage of pipe bore, crotch corner, and branch bore

All EDM notches on the main pipe bore and branch bore were successfully identified with inspection coverage improved for all parts; 100 percent coverage of the main pipe bore, crotch corner, and branch connection bore are shown for all thicknesses. Although detection capability using a multi-angle beam increased, it is important to note that defects must be favorably orientated for detection.

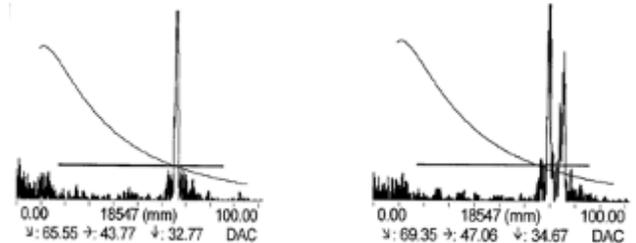
Figure 16: A-scan response from crotch corner (left) and response from defect found at branch tangent (right)

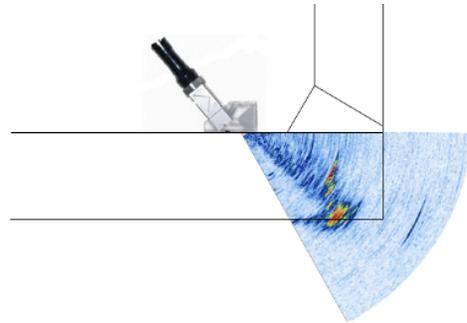
Figure 17: Phased array crack response from tangential scanning

Phased array ultrasonic testing has proven itself as a very powerful tool for detecting, sizing, and displaying the thermal fatigue cracking found within main pipe bores of branch connections tested. The high angular resolution combined with the high frequency probe provides a unique image of crack morphology not available with manual ultrasonic testing.
