Factors that affect the defect sizing capabilities of the Magnetic Flux Leakage Technique

Silverwing (UK) Ltd.

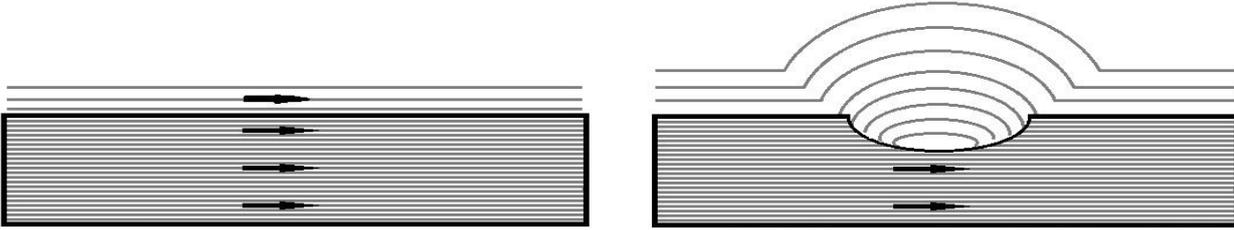
Over-saturation occurs when magnetic flux leaks from the inspection surface regardless of defect presence. It has been empirically proved that if an inspection surface is over-saturated, repeated scans of a symmetric defect will result in a consistent leaking field regardless of scan direction i.e. scan history is unimportant.

Moderate over-saturation is preferable because deformations in the leaking fields are likely to be easier to detect in real world applications⁴ as any added defect will accentuate the already leaking field in that area.
